## WHEEL OF FORTUNE

by John Anello - Auto Tech on Wheels

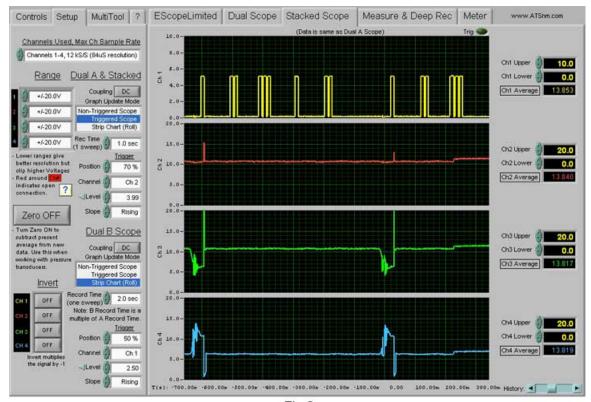
Fig 2

When I arrived at the shop I attempted to start the car but it only spit back a few times like it wanted to start. The shop tech told me that the #2/5 ignition coil was the only coil firing during cranking. The other coils did not fire at all. At this point I decided to hook up my scope to some selected signal lines to get a visual concept of what was exactly going on. I used my EScope Limited 4-trace scope and placed my channels on the cam sensor and all three coil drivers. As I cranked the engine you could see (figure 2) that the cam sensor was providing the proper signal pattern but the ECM had a problem controlling the coil drivers. One driver attempted to ground the coil while another driver

was held on for as long as 600mS of on time. By current ramping the one working coil against the crank and cam signals (figure 3) you could see that the coil driver was maintaining about 8.5 amps of current for almost one camshaft revolution. There is no way any driver would hold a coil primary that long unless that driver was in love and just did not want to let the coil go. It was a relationship that just went bad with no one to give advice to just let go. Someone was just not telling the ECM to let go of the coil. Now I am wondering if this caused the failure of the coil driver within the old ECM.

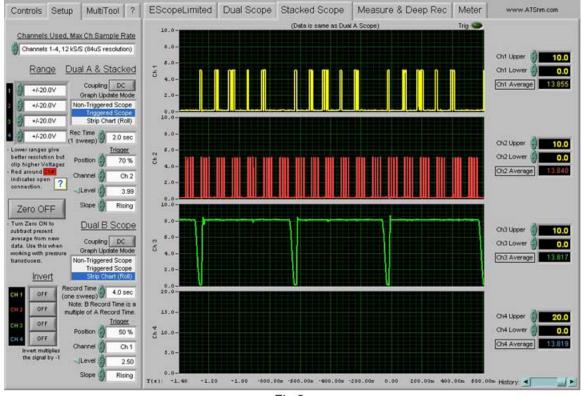
Fig 3

This erratic coil operation could only be caused by a defective ECM with an internal driver failure, a corrupted crank/cam signal input or a crank/cam sensor correlation problem. The cam and crank sensors seem to be producing the proper patterns with correct amplitude but I needed to compare their synch correlation. I used my Ace Misfire crank/cam waveform database and pulled up a good known crank/cam pattern for this vehicle (figure 4).

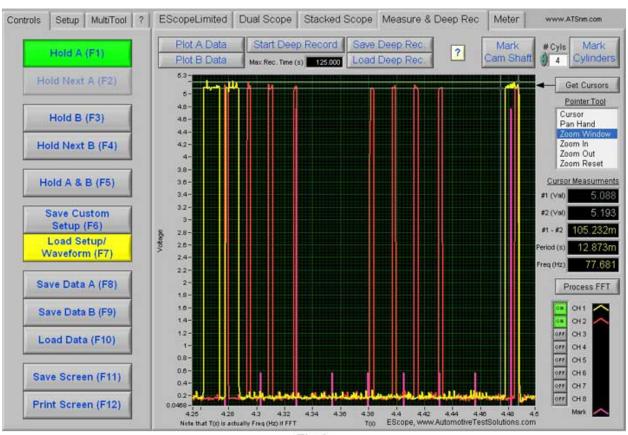
Fig 6

By hitting the Mark Cam Shaft button, the program automatically placed 5 purple cursors on the screen creating 4 divisions each representing 180 degrees of crankshaft rotation and 5 smaller purple cursors creating 6 sub-divisions each representing 30 degrees within each 180 division. I superimposed the crank signal on top of the cam signal and zoomed into the end and beginning event of the cam signal (figure 6). Notice how the crank signal has shifted at lest 30 degrees to the left. This indicated that the crank and cam sensors were not properly synched. The cam sensor indexed off the front of the engine while the crank sensor indexed off the torque convertor at the rear of the engine. Now I had to decide whether this was caused by a problem in the front or rear of the engine. With 108,000 miles on the clock it was a better sell from a maintenance point of view to disassemble the front of the engine to inspect timing chain components then it was to pull the transmission to check the flywheel assembly. The cause at this point could be a jumped timing chain, sheared crank key way, sheared cam gear roll pin or even a damaged flywheel. There was no flywheel noise while cranking the engine so where do you start with this dilemma without having to spend unwanted labor?

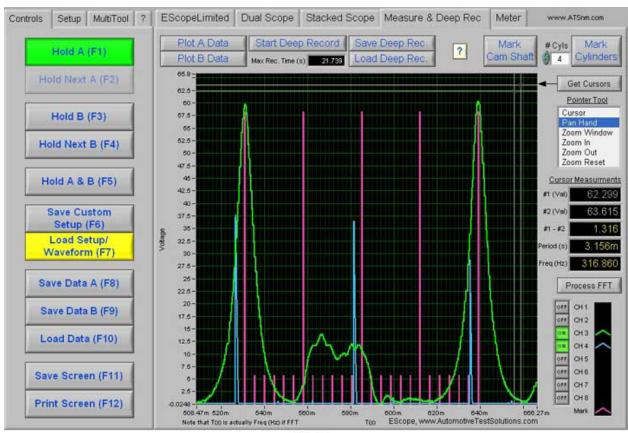
about 30-45 degrees before BDC of the power stroke on most of the cars I have been checking. The waveform pattern (figure 7) shows the exhaust valve to be opening close to 30 degrees before BDC of the power stroke. The spark was occurring only once in the cylinder when it should have occurred twice. The spark only fired the waste spark and fired wrong at about 40 degrees after TDC of the exhaust stroke. This was due to the incorrect coil primary control caused by the crank/cam correlation problem.

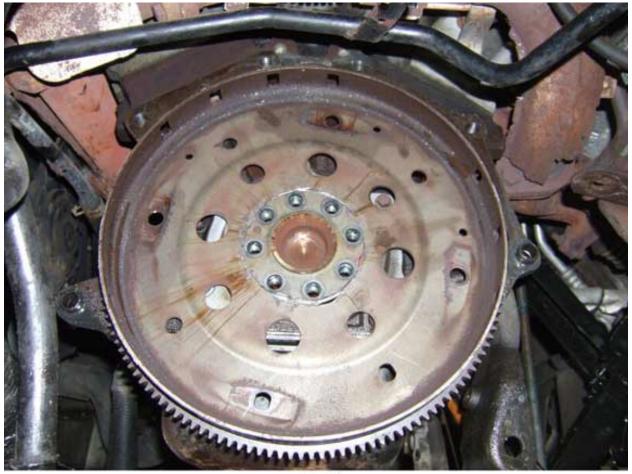
Fig 9

About an hour later the shop had called to tell me that the transmission was pulled and I needed to comeback to see the damage they found. When I arrived there at the end of my day I was amazed at the damage. The center of the flywheel was completely cut out from the rest of the flywheel like a cookie would be cut out of rolled dough. The center piece spun slightly and wedged itself in place (figure 9). The amazing thing was that there was no noise associated with this flywheel while cranking. I helped the garage remove the flywheel and placed it on the ground. I pushed on the center piece and it fell out. The only thing holding these pieces together were the center thrust plate and flywheel bolts. This flywheel was like a wheel of fortune just making the shop spend time & money without a cure in site and at the same time sending them on a wild goose chase. It held the torque converter and provided the crank triggers necessary to start the engine. Who would ever think a flywheel could break clean and spin but yet go undetected in its journey of unforgiving charades. I hope this story sheds some light on the value of a scope which allows you to have a window to see beyond the normal reach of a scanner.
