Hidden Pressure Hunt

James Garrido - Have Scanner Will Travel

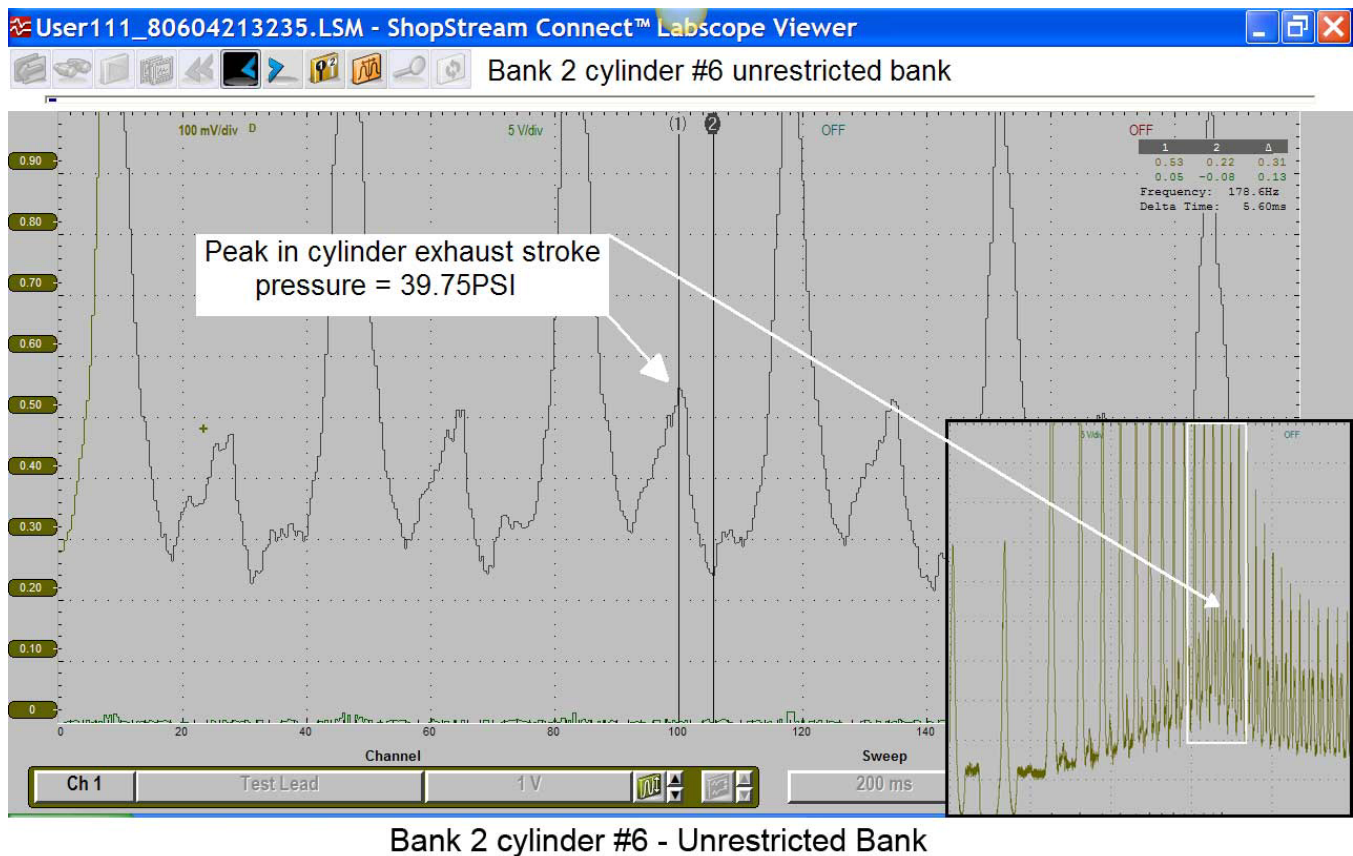
fig. 2

In figure 2 I have captured bank 2, cylinder 6, the good side of this engine. Compare these pressures waves seen from the good side to the clogged bank 1, cylinder 7 shown in figure 3. In the zoomed out capture shown in the lower right corner of the images you can see that the cylinder from the restricted bank built up more pressure on average than the cylinder from the unrestricted bank.

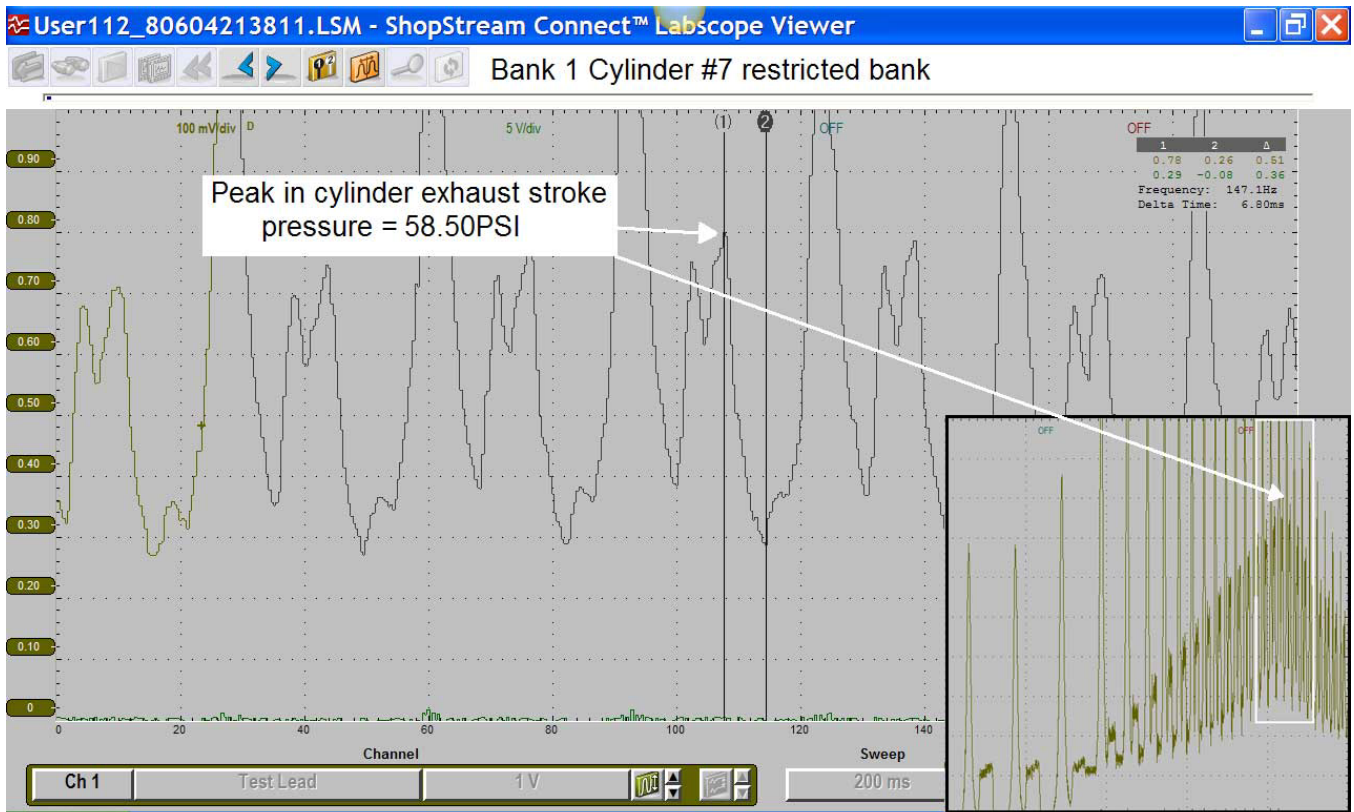
fig. 3

Bank 1 Cylinder #7 - Restricted Bank

If we zoom in on the highest in cylinder pressure peak section of the wave we can actually see the cycle by cycle difference between the cylinders on the different banks. On the bad cylinder you can see that the end of the exhaust stroke pressure wave plateau peaks at a high of 0.78V even after the pressure drops slightly as the intake valve opens during the overlap period. On the good cylinder you can see the exhaust stroke pressure wave plateau peaks at only 0.53V and then permanently drops off as the intake valve opens during the overlap period. The scaling on this sensor is 1.0V = 75 PSI so the variation between the restricted and unrestricted cylinders is 0.25V or 18.75 PSI! It is impossible to get this kind of accuracy and detail using older methods for testing for back pressure. Even a slightly clogged catalyst will show up by using in cylinder pressure measurements.
