1995 Jetta Crank / no start by Rusty Flake - Beck Service Center

Complaint: Car will turn over, but wont start.

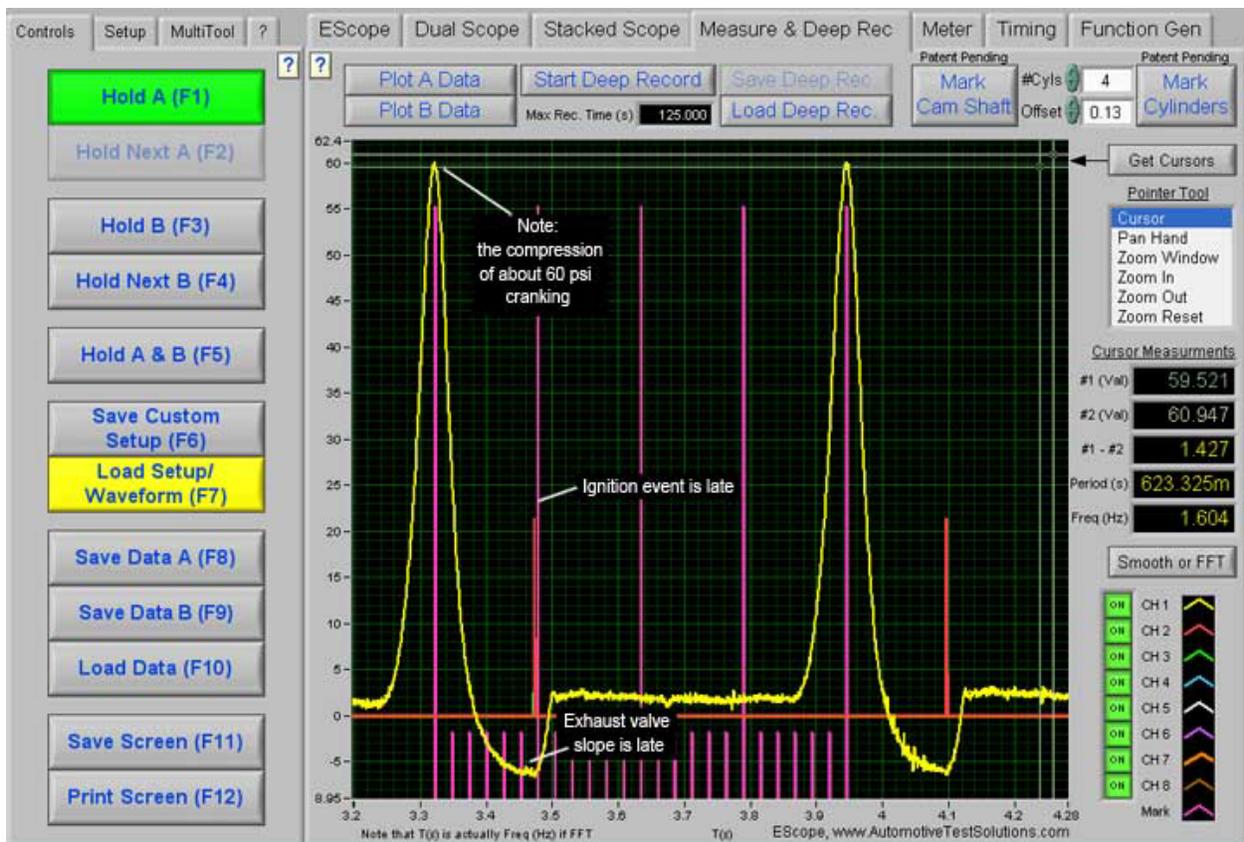
Fig. 1

Pressure transducers are fairly new to me, and I am still in the learning curve, but these things are great. I connected to cylinder 1 since it was already without the spark plug installed. And I synced off of that cylinder also. This waveform was interesting to me and only took about 30 seconds to capture on this car.

I called the technician working on the car over and told him I know that the ignition firing event is happening at the wrong time which would indicate to me that something in the timing components on this engine wasn't correct.

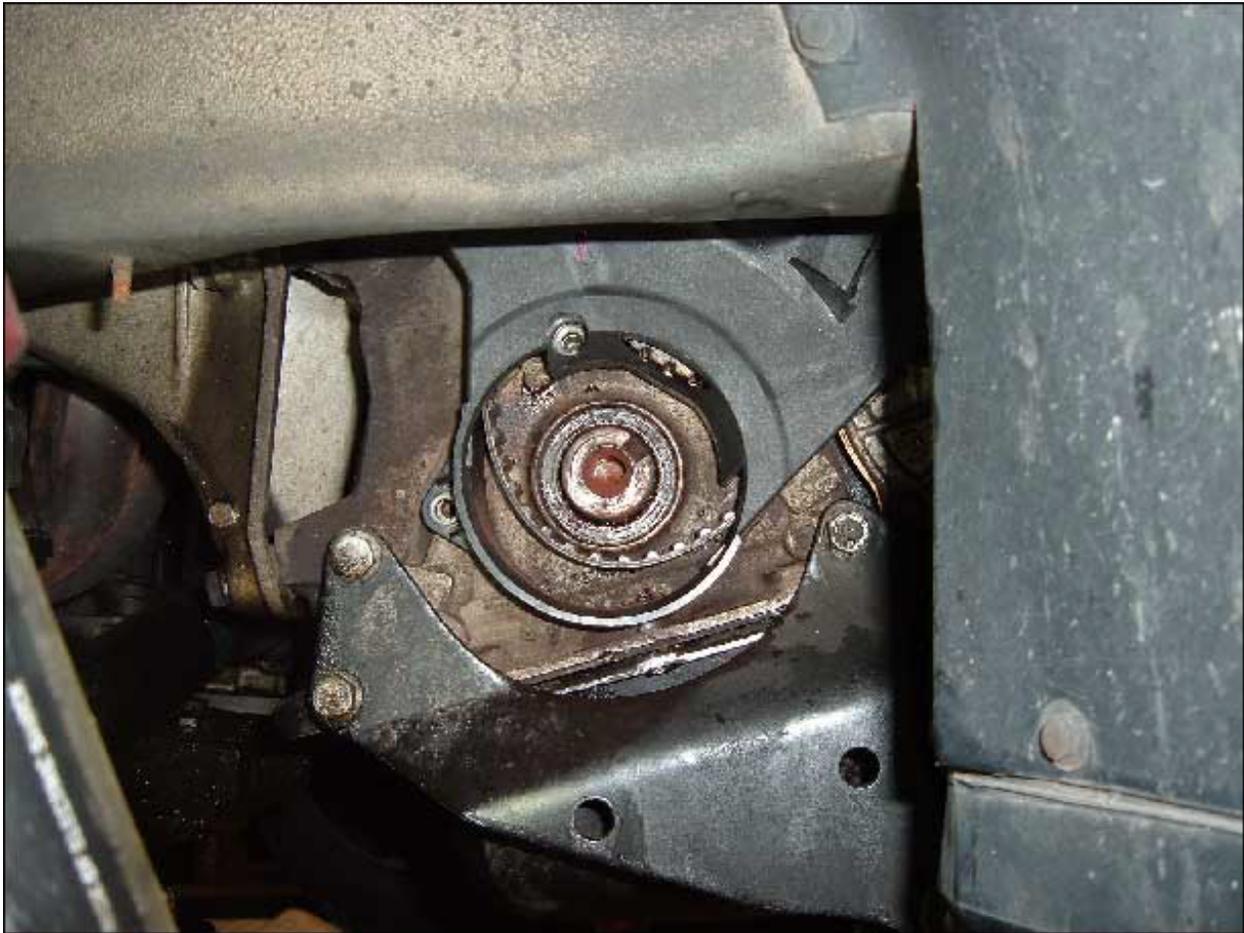
Fig. 2

I then suggested that the sprockets be removed to make sure that the dowel and or woodruff key had not broken or elongated the slots they go in. Figures 2 & 3 show the main problem with this car. A new crankshaft sprocket was ordered and installed with a new timing belt, and the car started.
