## WHEEL OF FORTUNE

by John Anello - Auto Tech on Wheels

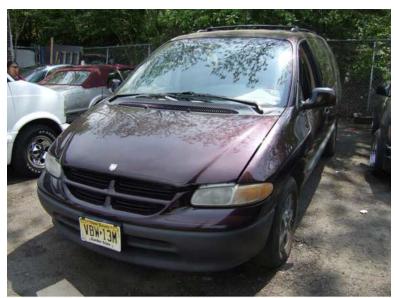
Fig 1

I was called to a shop with a complaint of a no start condition on a 1996 Dodge Caravan with a 3.3L engine (figure 1). This shop only had a scan tool in its arsenal of equipment. No scope, no graphing meter combined with a component tester or even a repair information system. With no codes in memory the shop resorted to the feels like tactics. They used their best instincts to replace parts associated with their visual inspections and old school test procedures. The spark tester they were using only showed spark on one coil so the list included coil pack, crank sensor, cam sensor and an ECM. The old ECM was bad due to a damaged coil driver that was holding one coil primary constantly on. This I have seen many times in the field caused by a bad coil assembly with a shorted coil primary winding. So I can justify their replacement of the coil assembly and the ECM but the vehicle at this point still had a problem with a no start. This shop is not alone in the way they diagnose cars. All too often I cater to these type of shops and I try my best to educate on site how important it is to keep themselves up to date on training and have the proper equipment to perform tasks that will only save them time and unwanted parts. It will only make them a better technician in the long run. It is never too late to step up to the plate to take it to the next level. The worst thing in any business is to let technology surpass you. You will only find yourself stuck in the past with not much of a future to keep afloat.

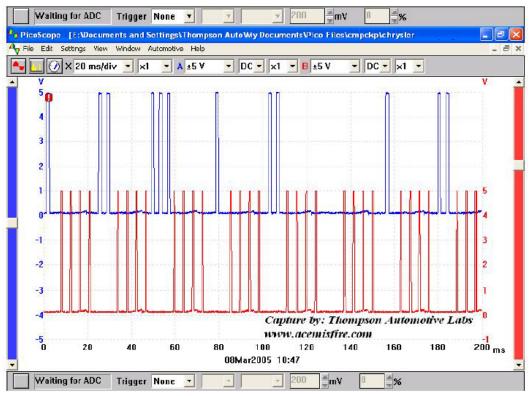
Fig 4

This erratic coil operation could only be caused by a defective ECM with an internal driver failure, a corrupted crank/cam signal input or a crank/cam sensor correlation problem. The cam and crank sensors seem to be producing the proper patterns with correct amplitude but I needed to compare their synch correlation. I used my Ace Misfire crank/cam waveform database and pulled up a good known crank/cam pattern for this vehicle (figure 4).

You can see how the cam sensor pattern repeats the 1-2-3-1-2 pattern while the crank signal repeats the 4-4-4-4-4 pattern. It is between where the cam pattern ends and begins that there should be equidistant 4-4 patterns. I imported the cam sensor signal into the measuring section of the scope (figure 5) and placed cursors to show one complete event of the cam sensor.

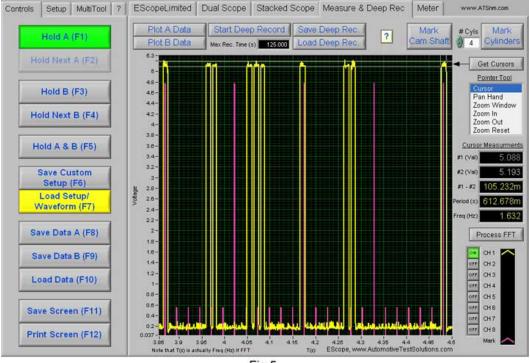
Fig 5

By hitting the Mark Cam Shaft button, the program automatically placed 5 purple cursors on the screen creating 4 divisions each representing 180 degrees of crankshaft rotation and 5 smaller purple cursors creating 6 sub-divisions each representing 30 degrees within each 180 division. I superimposed the crank signal on top of the cam signal and zoomed into the end and beginning event of the cam signal (figure 6). Notice how the crank signal has shifted at lest 30 degrees to the left. This indicated that the crank and cam sensors were not properly synched. The cam sensor indexed off the front of the engine while the crank sensor indexed off the torque convertor at the rear of the engine. Now I had to decide whether this was caused by a problem in the front or rear of the engine. With 108,000 miles on the clock it was a better sell from a maintenance point of view to disassemble the front of the engine to inspect timing chain components then it was to pull the transmission to check the flywheel assembly. The cause at this point could be a jumped timing chain, sheared crank key way, sheared cam gear roll pin or even a damaged flywheel. There was no flywheel noise while cranking the engine so where do you start with this dilemma without having to spend unwanted labor?
